Manhole Inspection Summary

Manhole # S23KK_021MH

Location Address: **1515 NORTH AVE**

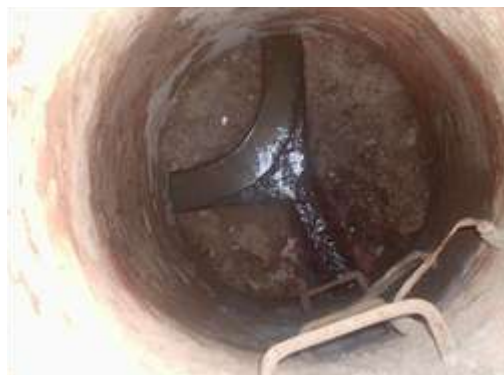
Top View

Corroded steps. Evidence of surcharge - Bench debris.

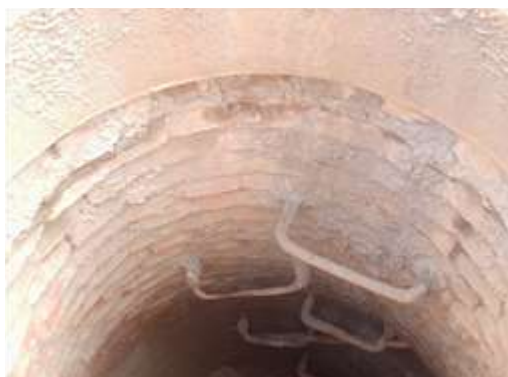
Defect

Frame leaks. Adjustment deterioration and infiltration. Corbel and Barrel infiltration - other side.

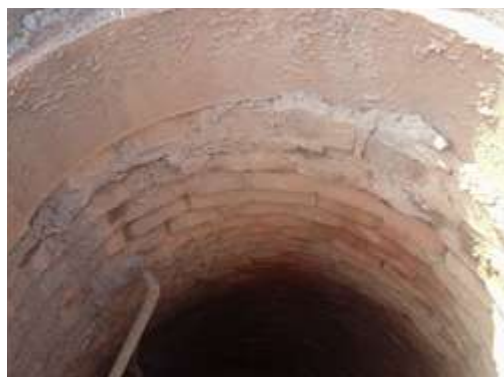
Defect

Frame leaks. Adjustment deterioration and infiltration. Corbel and Barrel infiltration.

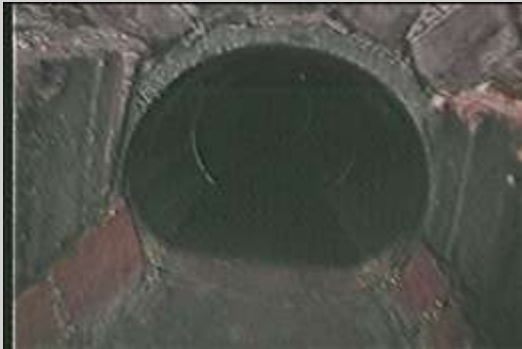
8 in. Circular Gravity Sewer Pipe Out @ 12 O'Clock

Infiltration: **Evidence** Pipe Seal Cond: **Cracked**

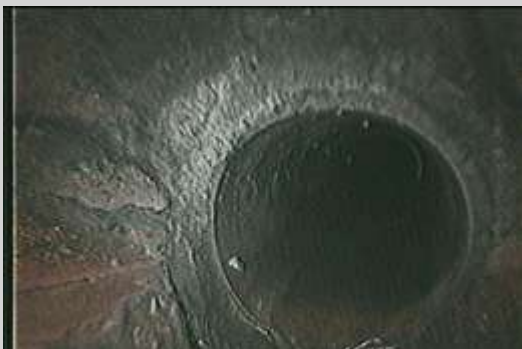
6 in. Circular Gravity Sewer Pipe In @ 5 O'Clock

Infiltration: **None** Pipe Seal Cond: **Cracked**

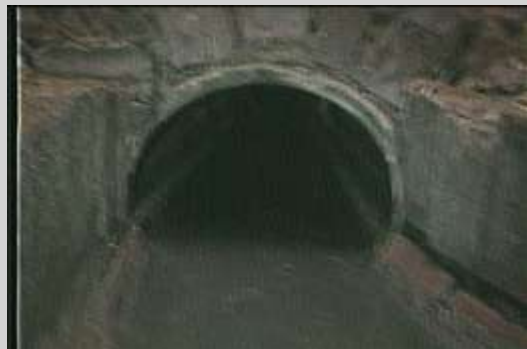
Pipe In @ 9 O'Clock

Deposits: ☐ None ☒ **Mud** ☐ Sludge ☒ **Debris** ☒ **Grease**

Silt Depth: **0.5** (in.)

Deposits Extent: **Light**

Pipe Seal Cond: **Cracked**
